Set-up for testing module 123

NSS2004 Sebastian Bachmann
University of Heidelberg

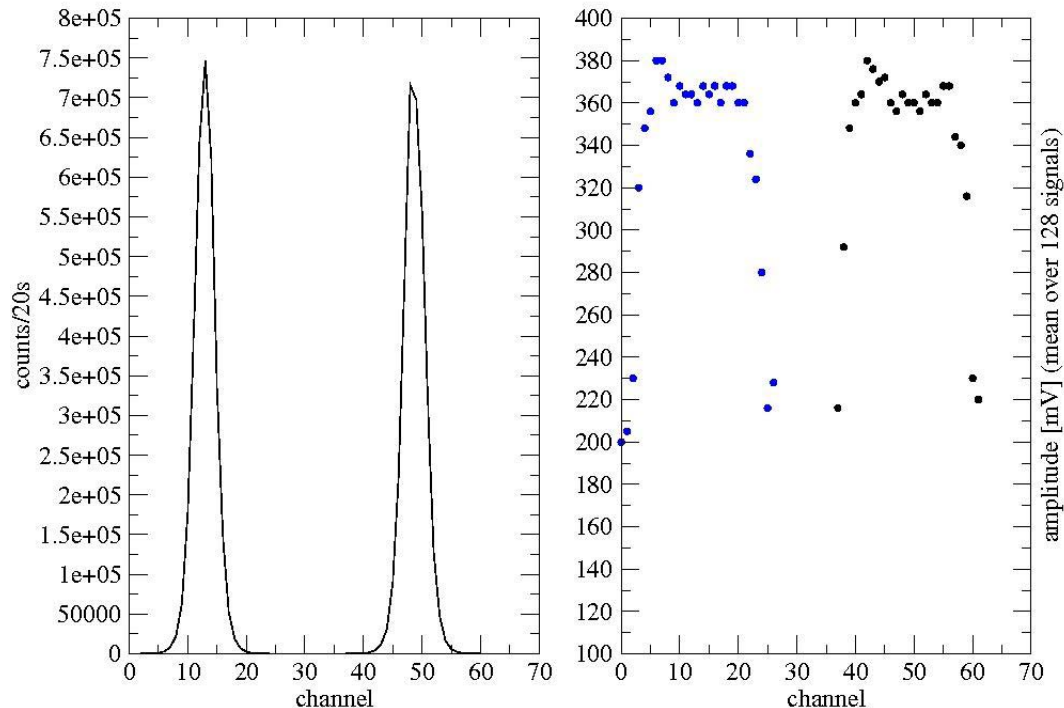
Test 07.12.05

No effect has been seen in the corresponding measurement for the lower module side:

Pulseheight from ^{55}Fe
Before irradiation
(decrease of pulse height at the edge is understood. It is NOT due to decrease of gas gain. The reason is that in this region the rate from ^{55}Fe is comparable to cosmic. Therefore the smaller pulse height from cosmic dilutes the measurement).

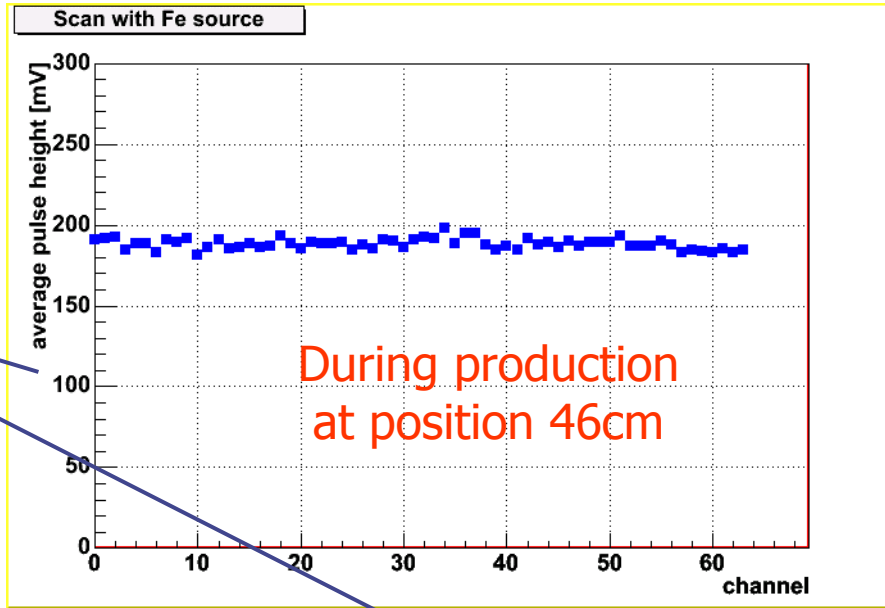
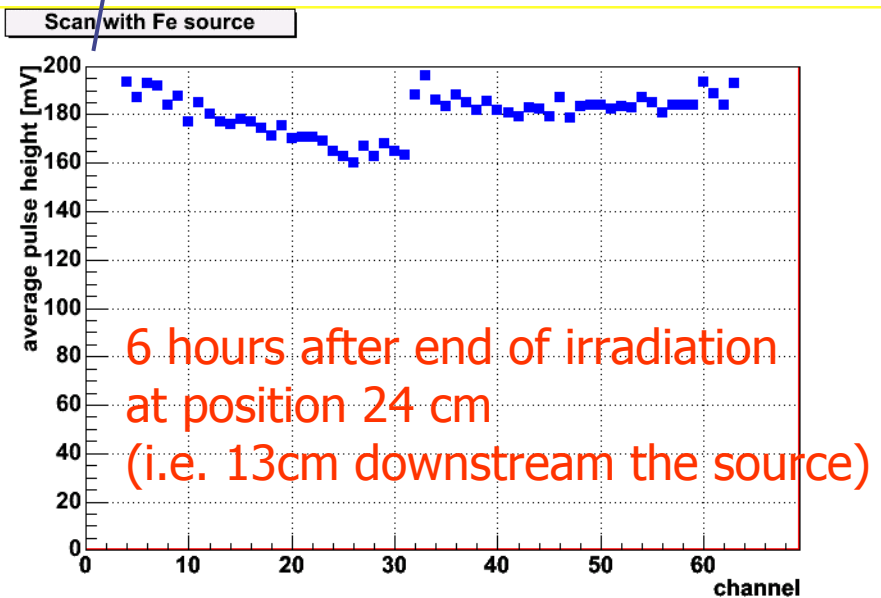
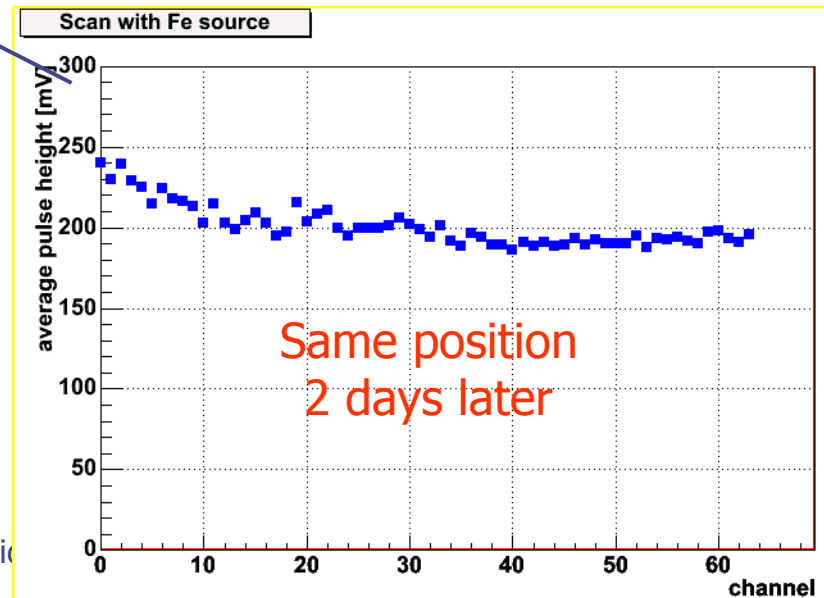
Is the effect permament?

Note different scales!

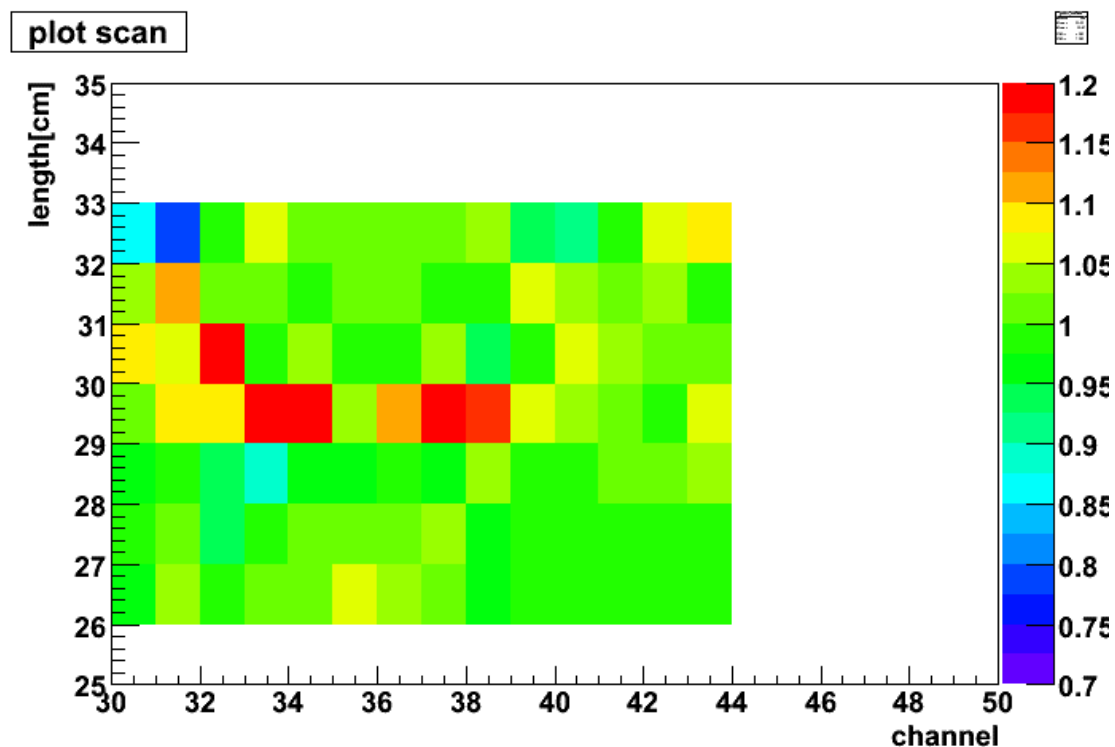
Apply reversed voltage

For ~ 12 hours a voltage of 1300V with inverted polarity was applied to Module 52.

The plot shows the ratio of the pulse height before and after the irradiation.

The scanned spot has been irradiated before (see page 20):

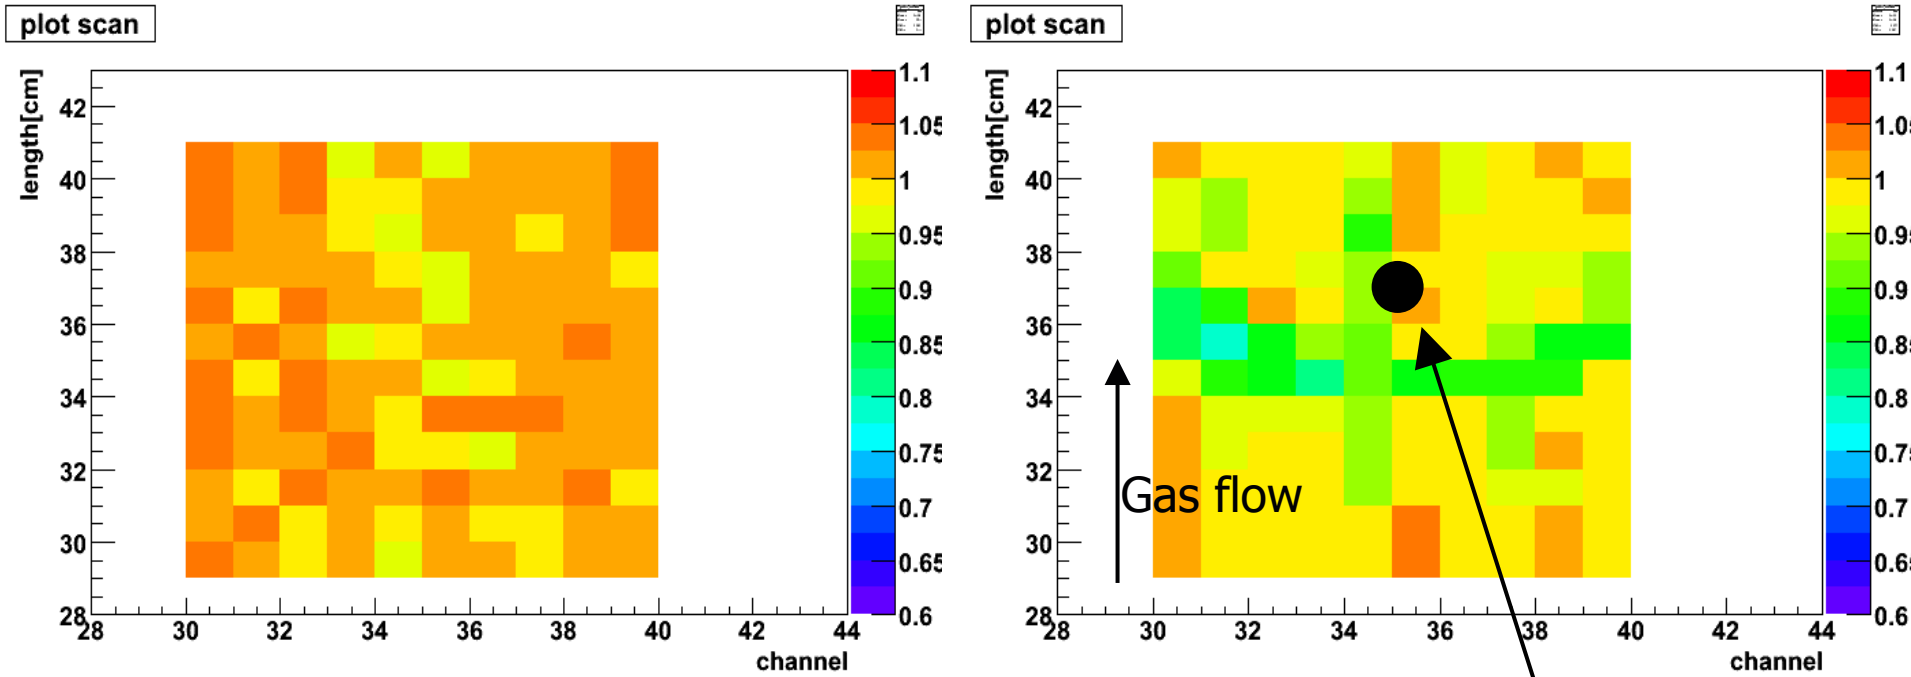
Scans before and after irradiation:

Note: Effect is small but measurement has been done at a low gas flow (~ 0.5 vol. exchanges/hour).

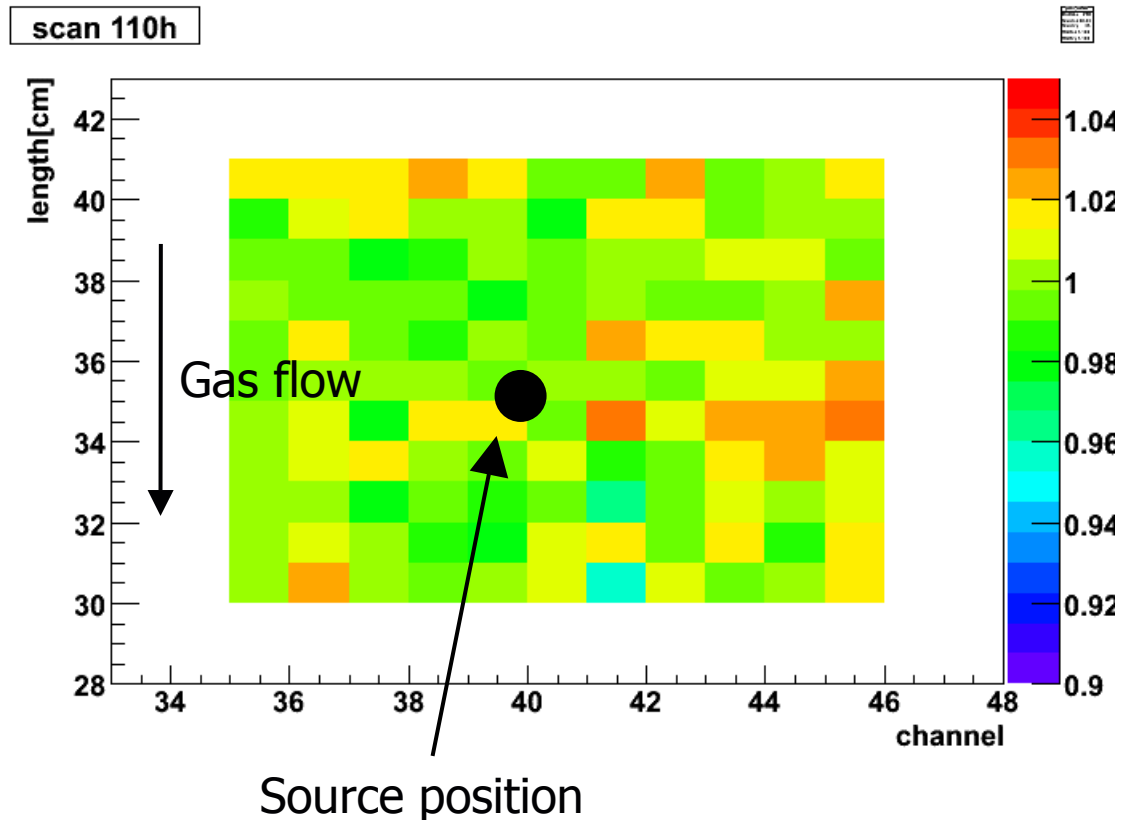
Try to force effect in 1m module

To enforce the effect in the module we:

- increased the gas flow to 12l/h
- added 4x3 gas pipes from the production at the gas inlet
- operated the module in the exhaust of a F-module

but after additional 68hours of irradiation we see no effect:

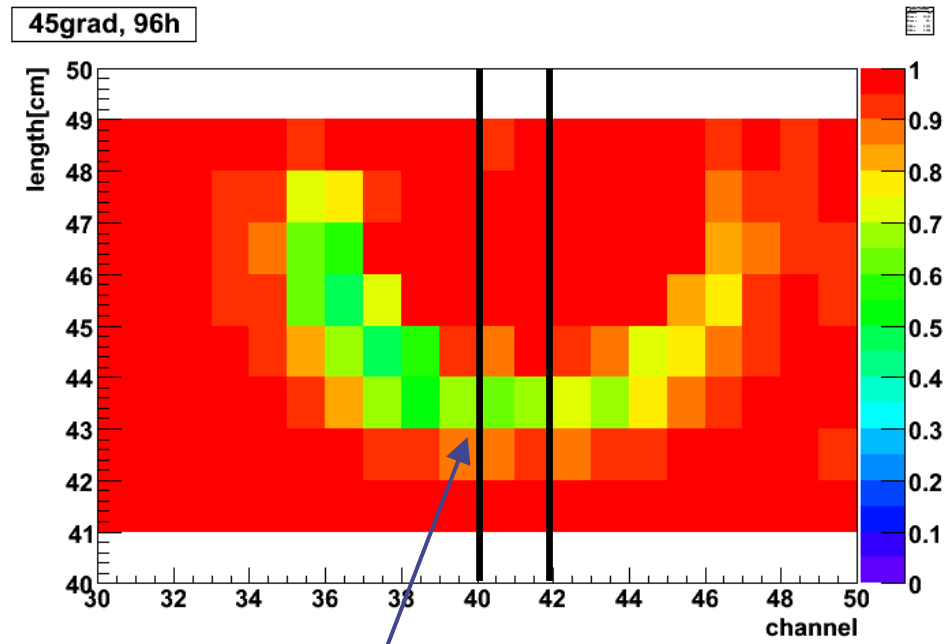
Module 52 has been opened

We opened module 52 and inspected wire from the irradiated region. Parameters for irradiation see page 28.

In this region the straw cathode is more dull. The effect is sharply bordered.

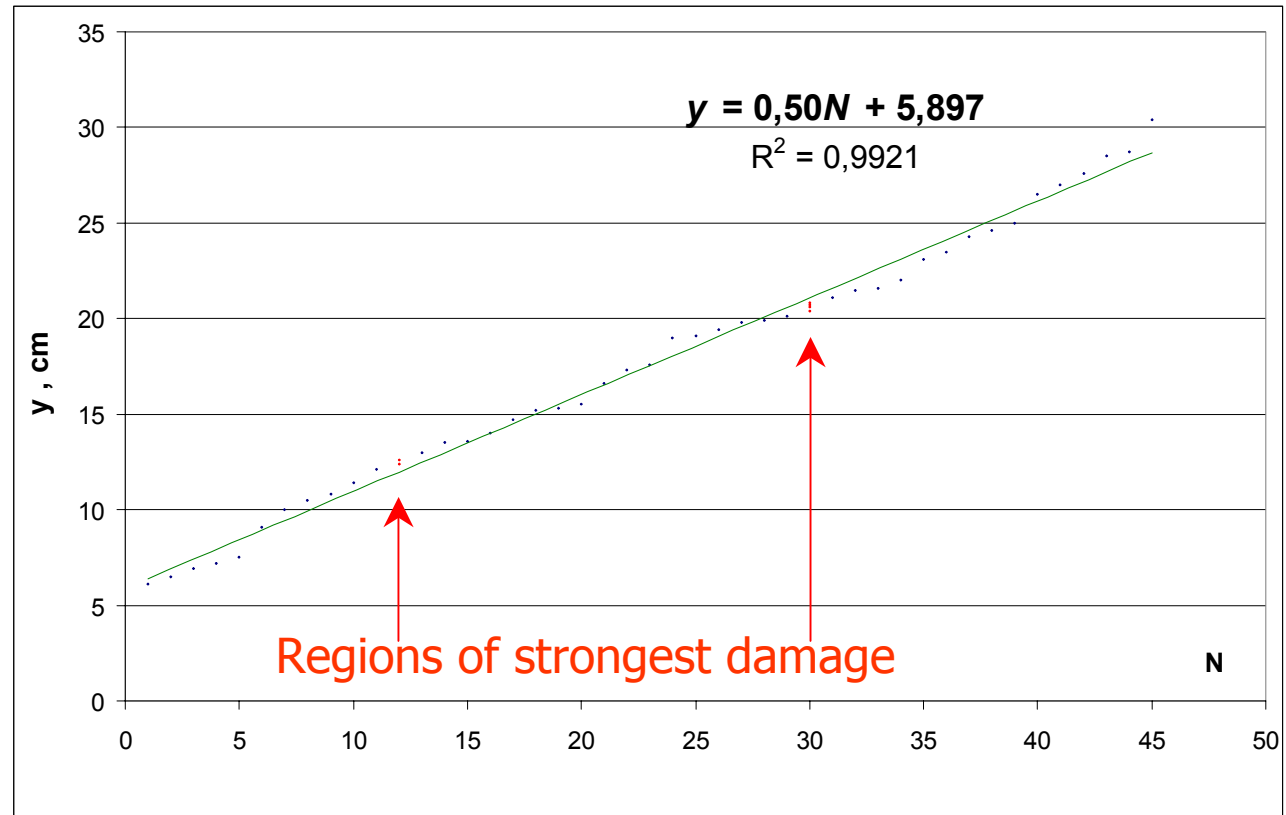
Remark

For wire 40 and 41 the damage is very well localized in two spots.

For wire 42 there are two spots with major damages, but there are damaged spots regularly distributed over the entire wire.

The diagram shows the position of spots along the wire (Note the arbitrary Units for the ordinate).
