Set-up for testing module 123

NSS2004 Sebastian Bachmann
University of Heidelberg

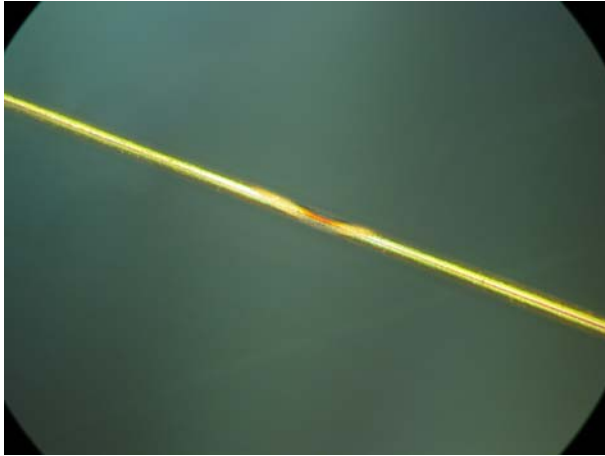
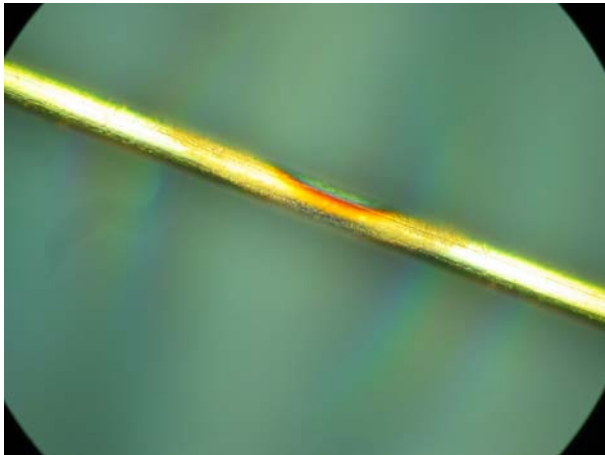
Wire 42:

For wire 42 there are two spots with major damages, but there are damaged spots regularly distributed over the entire wire.
